# Skellig Michael World Heritage Site

## Management Plan 2008–2018

July 2008

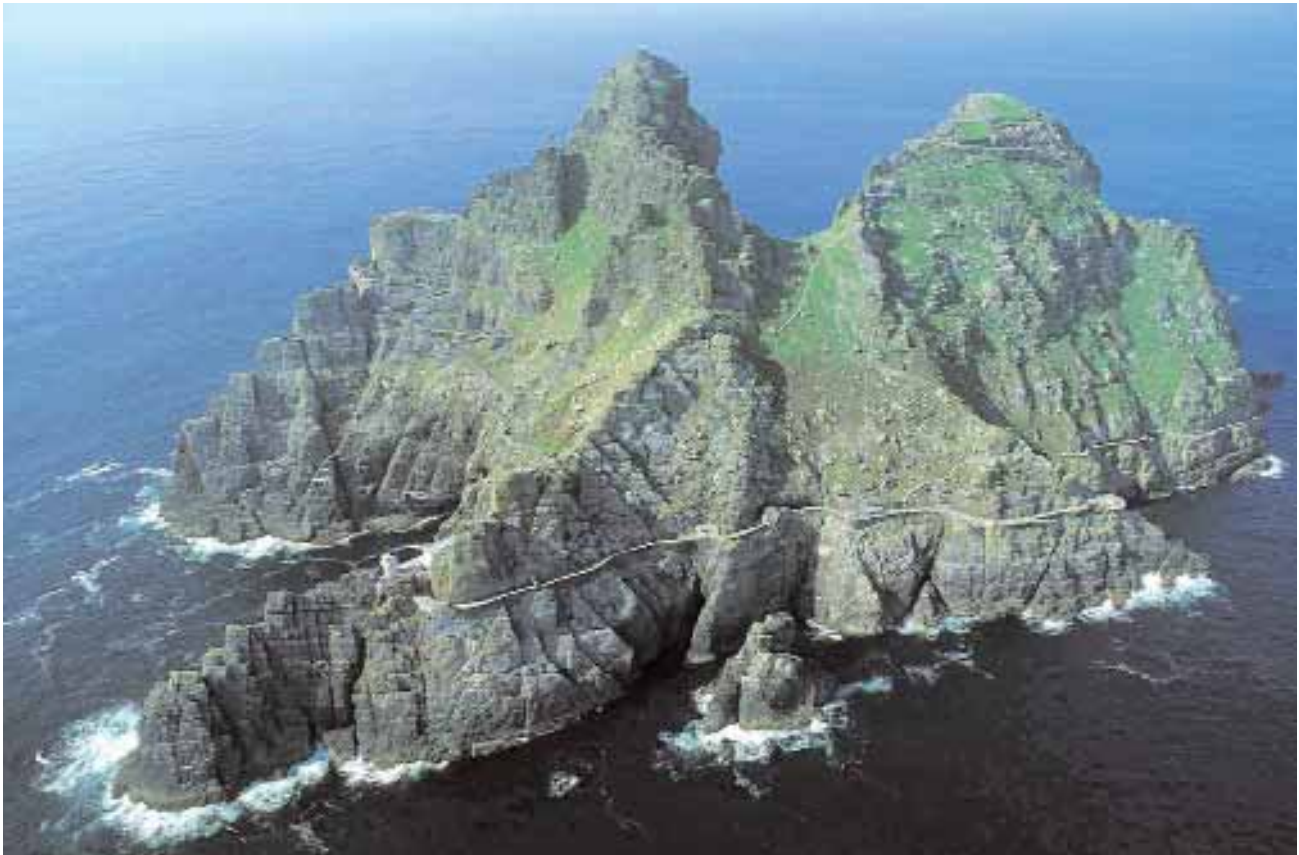
*Pl. 2 - Aerial view of Skellig Michael, from south, showing the two peaks, Christ's Saddle and the Lighthouse Road.*

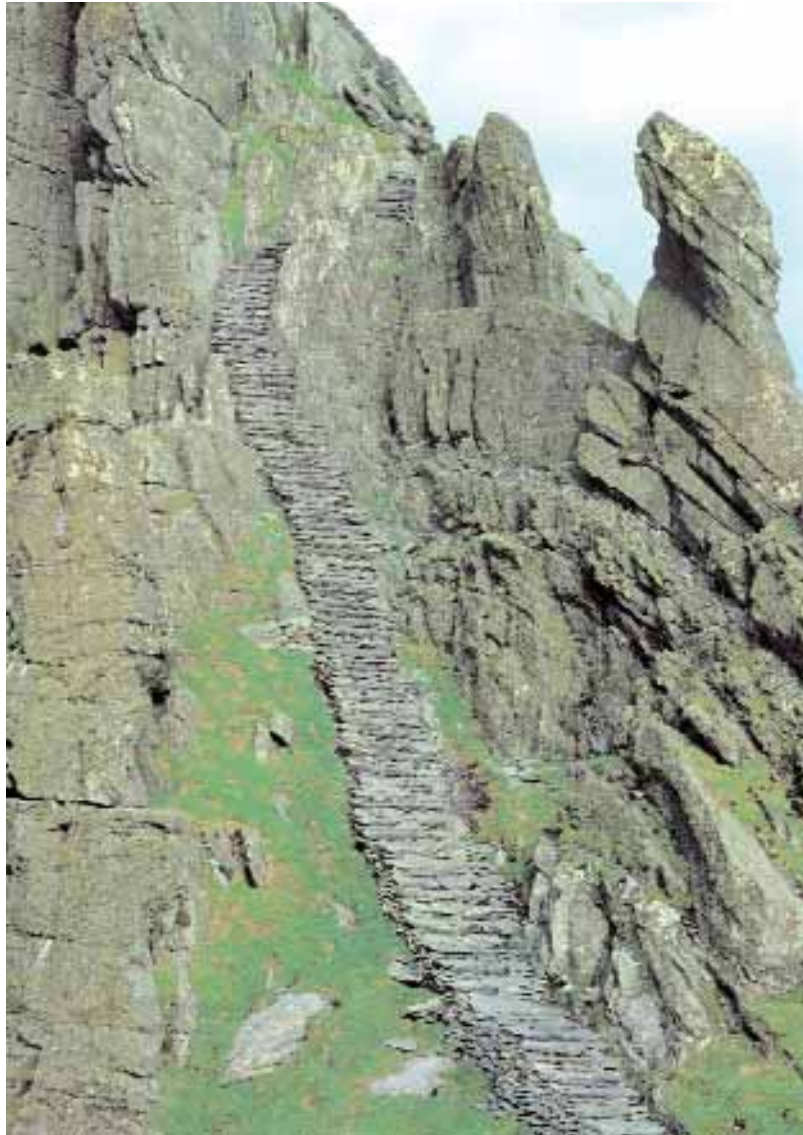
*Pl. 3 - The Upper Section of the South Steps,  
leading up to the Monastery.*

Three long flights of steps (East Steps, South Steps and North Steps) lead up to the Monastery from three different landing places. They comprise initially of rock-cut steps, which later give way to drystone construction. The base of the East Steps and a lower section of the South Steps were destroyed during the construction of the pier and Lighthouse Road in the 1820s.

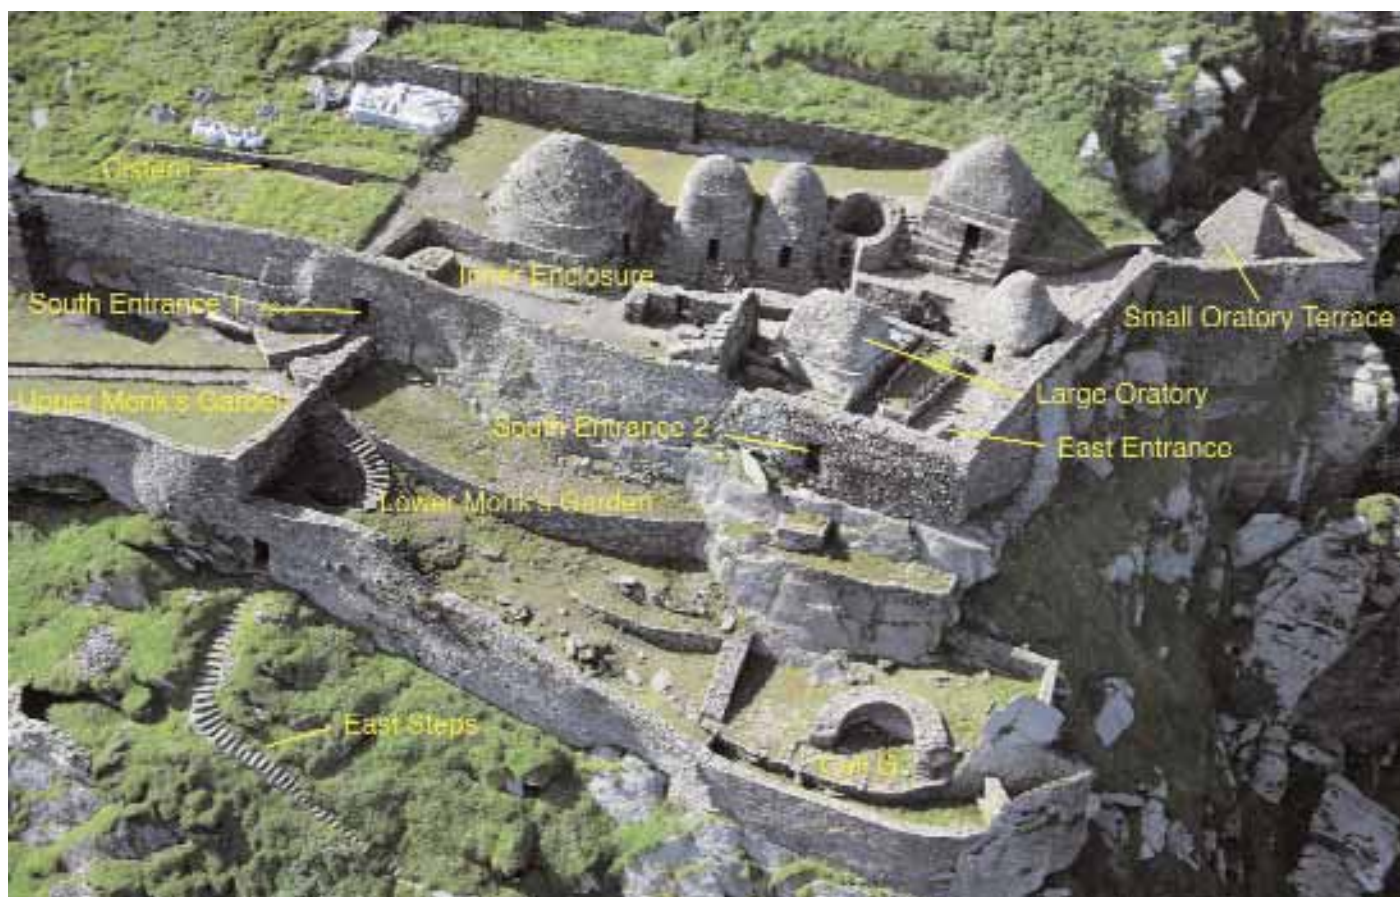
*Pl. 4 - Aerial view of the Monastery, showing the inner enclosure (illustrating location of cells, oratories, church and leachta of the Lower Monks' Garden, with the remains of an earlier cell (G)). This view also shows top of the East Steps and original entrance into the Monastery.*

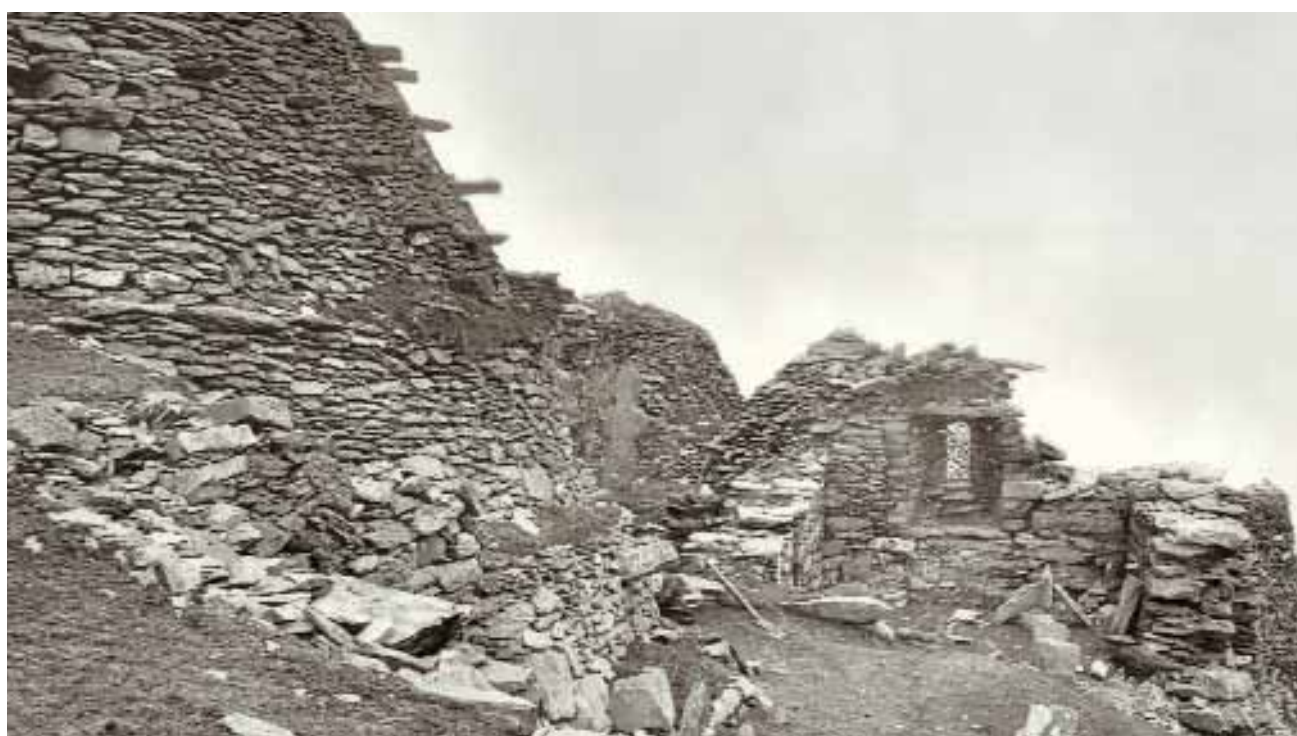
Pl. 7 - View of St Michael's Church, showing collapsed retaining wall on the south side, published in 'Notes on Irish Architecture'.

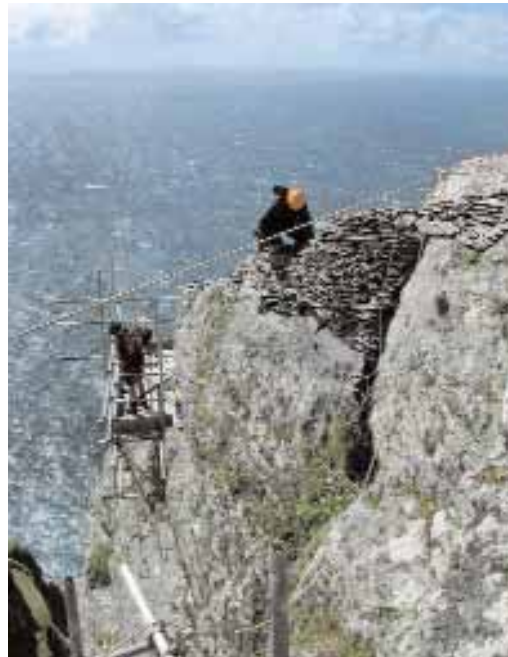
*Pl. 14 - Working on the stabilisation of structures on the South Peak.*

In the case of Skellig Michael, one of the most fundamental issues is that of structural stability. Until structural stability is achieved, no other conservation works can be undertaken, except for temporary remedial or holding works. Only when stabilisation has been achieved can final consideration be given to detailed conservation and presentation.

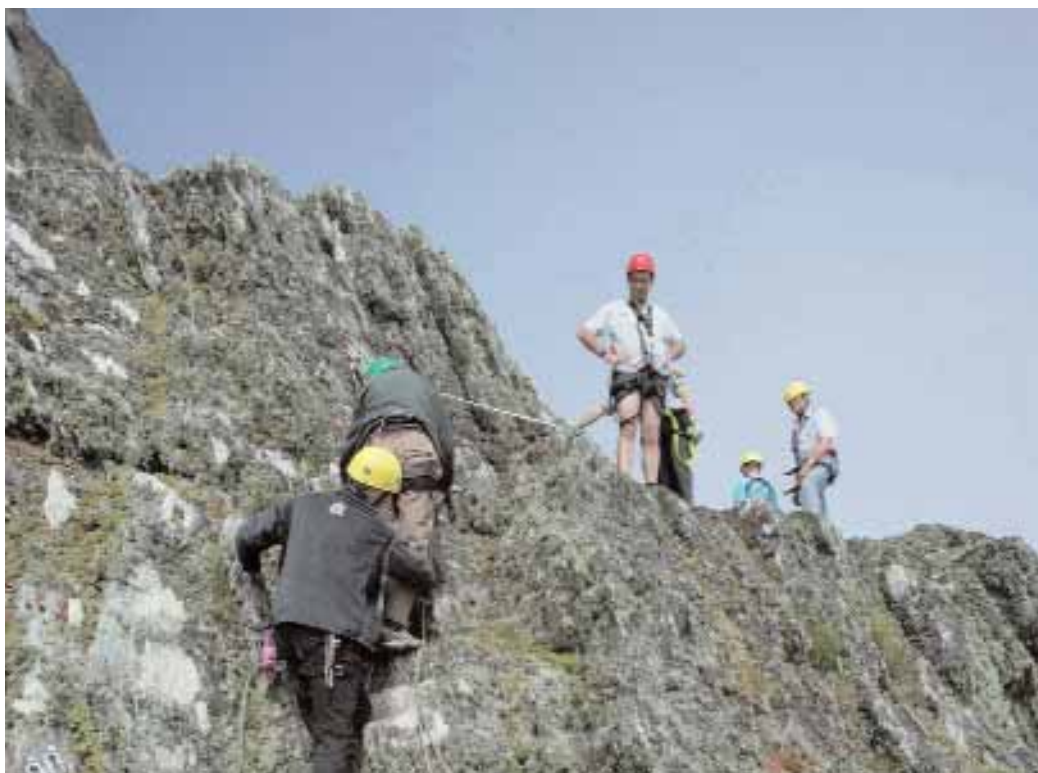
*Pl. 15 - Working on the South Peak aided by ropes and overseen by a full-time Safety Officer.*

Specialist activities, such as rope access and the use of safety harnesses, are the responsibility of a specialist contractor. All personnel working on Skellig Michael are both suitably trained and equipped to complete the work in a safe manner. At the start of each season all works employees on Skellig Michael have their safety skills updated. In relation to 'Working at Height', all works employees are assessed and trained annually for the tasks to be undertaken.

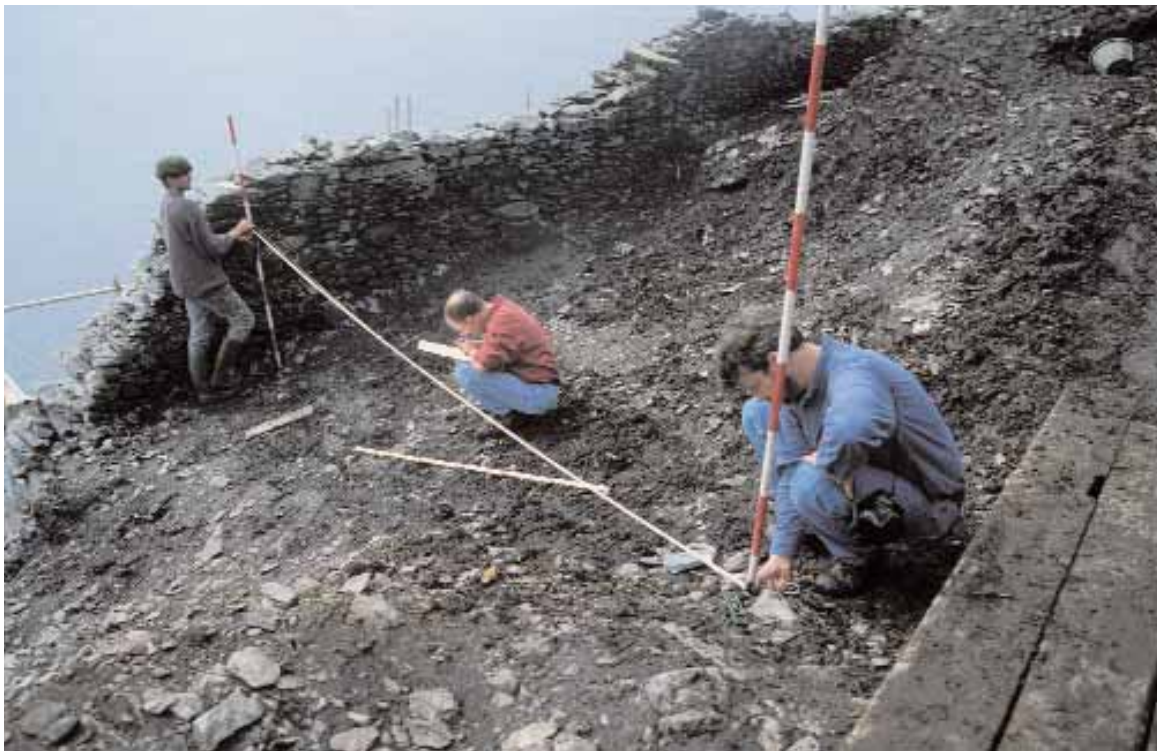
*Pl. 16 - Survey work on the Lower Monks' Garden prior to excavation and after removal of vegetation.*

Measured surveys and photographic surveys are carried out before any works commence. Much of this work is carried out by the conservation team and, given the nature of the terrain, plane table surveys are used extensively. Plans, sectional profiles and elevations are recorded at differing scales during excavation; instrument surveys have been used to record the features after excavation.

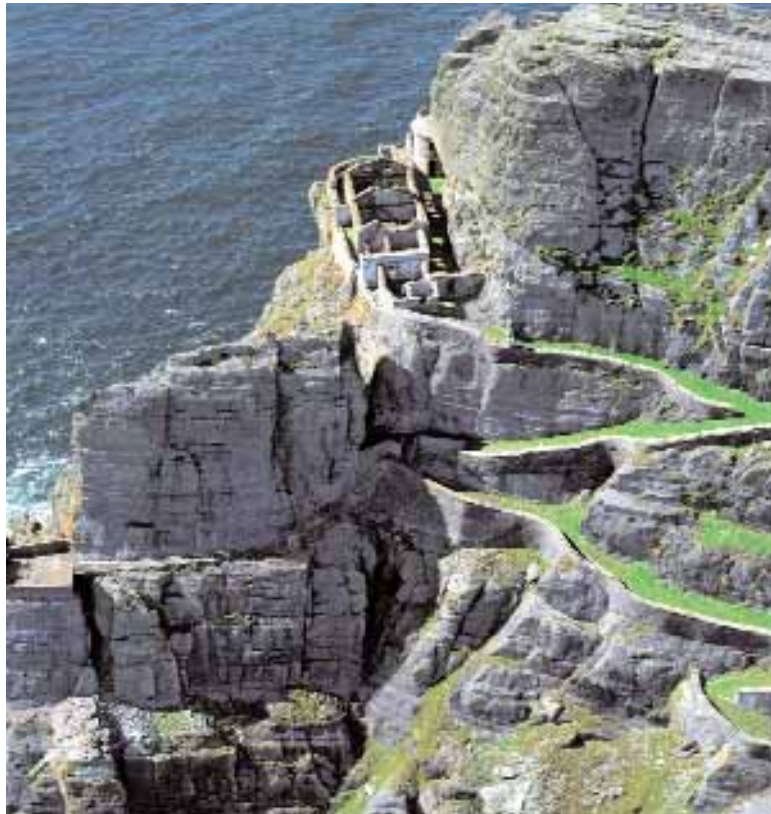
*Pl. 19 - View of the Upper Lighthouse Road and Upper Lighthouse, now disused.*

The Upper Lighthouse is in a ruinous state and is in poor condition. A detailed survey has yet to be undertaken, but this will involve a structural appraisal of each of the buildings. The lighthouse and its associated structures will require both structural consolidation and conservation.

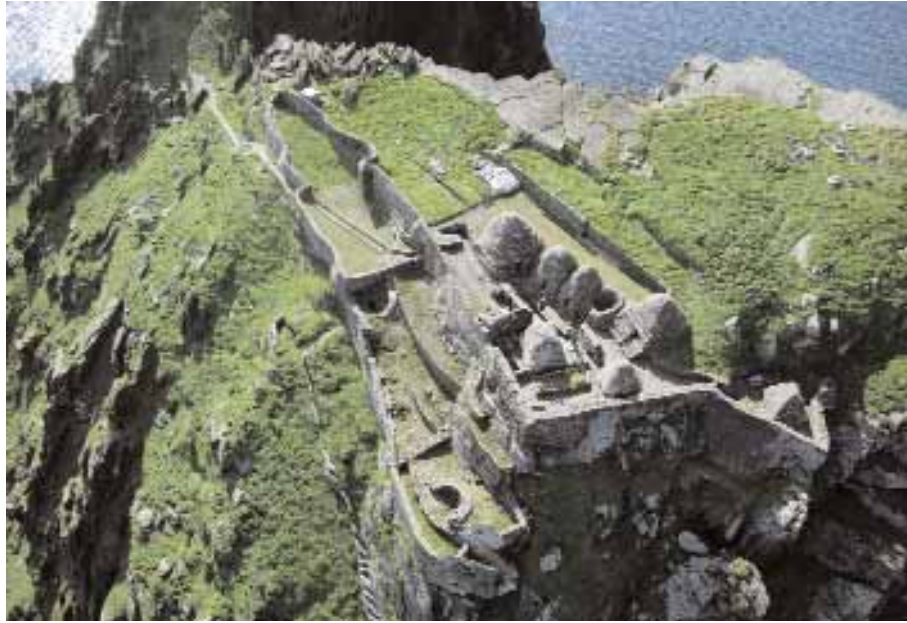
The Monastery comprises two oratories, a mortared church, six cells (one of which is in a ruinous state), the remains of a beehive toilet, cisterns, a cemetery, *leachta*, crosses and cross-slabs. It also includes two large terraces referred to as the Upper and Lower Monks' Gardens. The Lower Garden houses the remains of two very early structures.

*Pl. 22 - Aerial view of the Monastery, showing the inner enclosure and the Upper and Lower Monks' Gardens.*

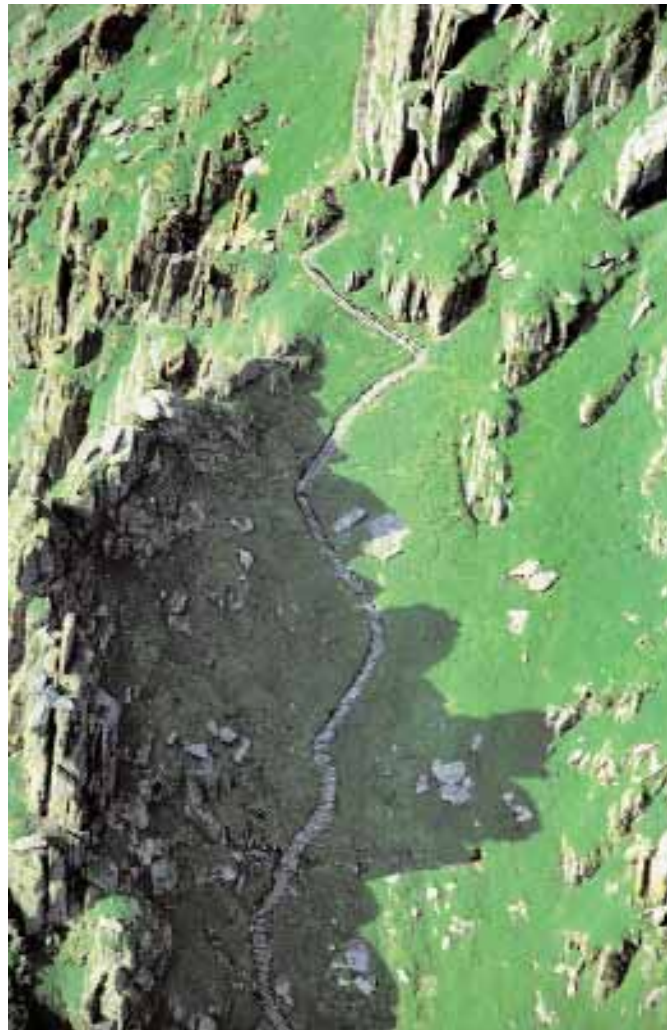
The base of the East Steps was blasted away by the lighthouse-builders when they constructed the pier and the Lighthouse Road. Above this level the steps have been conserved and are in very good condition. The remains of a structure, which may have sheltered a boat or housed provisions, are located here.

*Pl. 24 - Aerial view of the East Steps.*

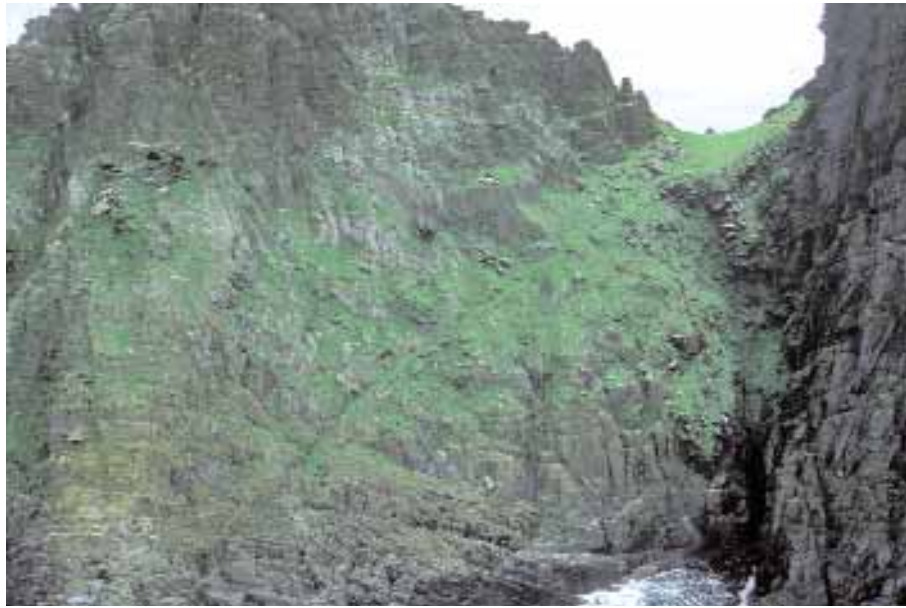
The North Steps were used extensively by the lighthouse-builders. The lower, stone-cut section has been very worn by the action of the sea. A parapet was added at the lowest section of the drystone steps, which are in one long, continuous flight. The steps have been repaired, but due to collapse on the very steep ground it has not been possible to recover all of the steps and some sections have been ramped. Neither the East nor the North Steps are accessible to the public.

*Pl. 25 - Aerial view of the North Steps.*

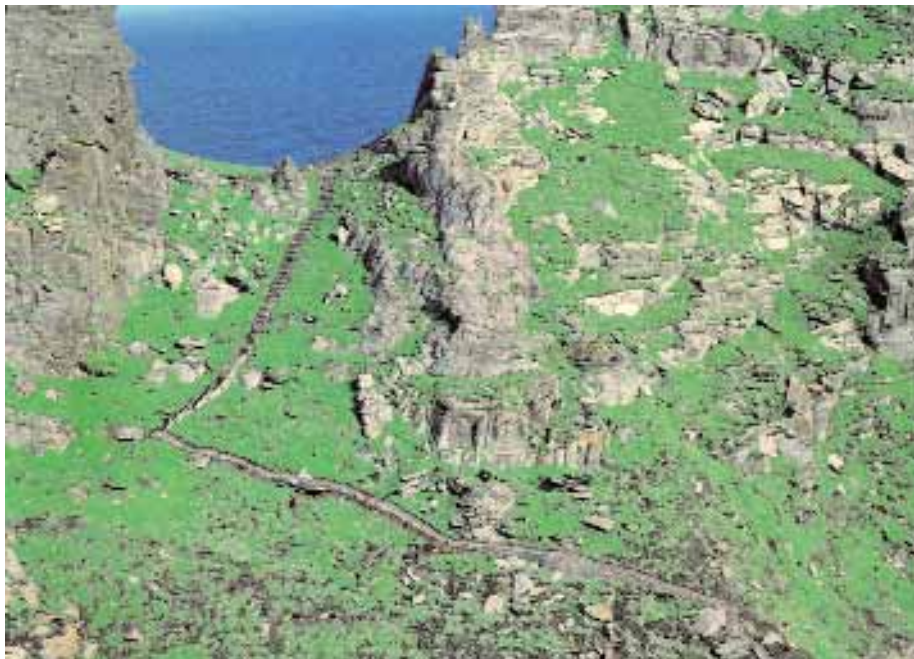
The South Steps are used by visitors today and are accessed from the lighthouse road. The South Steps join the North Steps at Christ's Saddle and continue as one flight up to the Monastery. There are other structures associated with these steps. There are remains of walling, which was probably used to create level terraces. These terraces may have been used to cultivate foodstuffs. Alongside the steps are the remains of a substantial prayer or pilgrimage station. There are also the remains of a lighthouse platform and a lighthouse toilet. At Christ's Saddle there is a constructed 'cave' or shelter.

*Pl. 26 - Aerial view of the South Steps, leading to Christ's Saddle.*

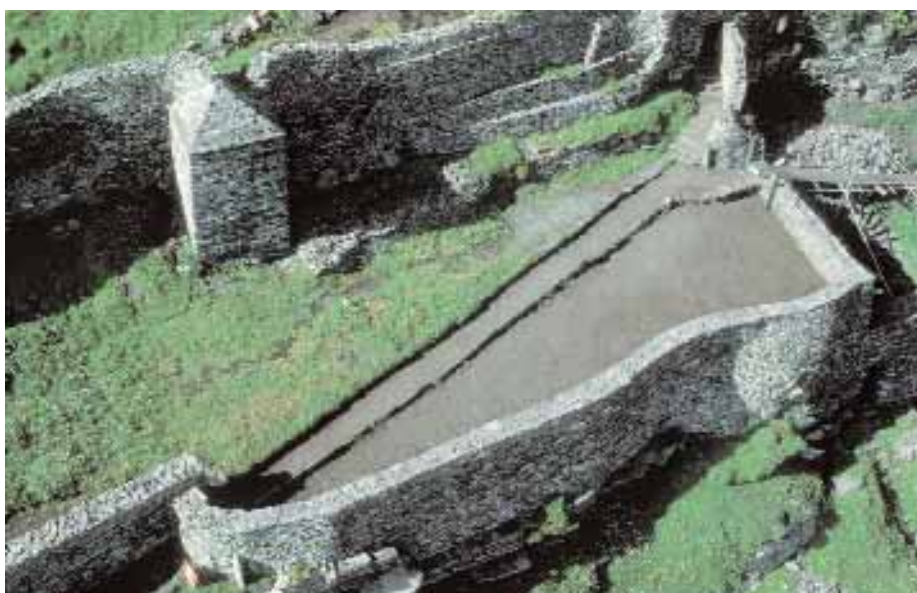
The Monastery is accessed via what are known as the Upper and Lower Monks' Gardens. The present entrance into the Upper Monks' Garden is not original and was possibly constructed in the early nineteenth century. This garden would have provided a suitable area for growing vegetables: it is south-facing and well shielded from the elements. Archaeological excavation of the Lower Monks' Garden uncovered the remains of a very early circular, drystone cell surrounded by paving. This cell is very similar to the cell on nearby Illaunloughan. This discovery indicates that the 'garden' was never used solely for cultivation. The remainder of this 'garden' is very steep, but it is possible that small cultivation terraces were located here.

*Pl. 28 - Aerial view of the Upper Monks' Garden.*

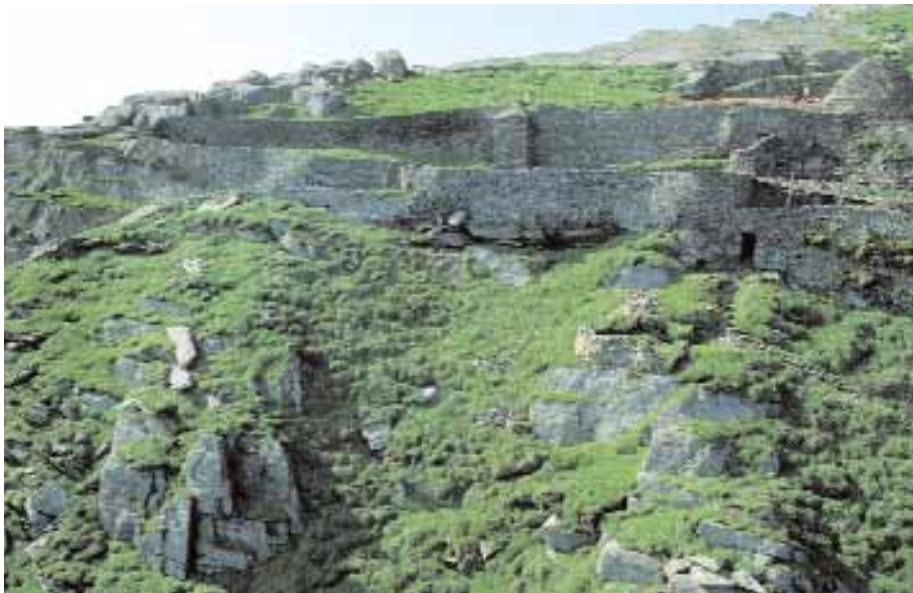
Pl. 29 - Aerial view of the west end of the Monastery, showing the retaining walls.

The long, lower, south-facing retaining wall has also suffered repeated collapse. Most of the retaining wall holding the Upper Monks' Garden had collapsed and was substantially rebuilt in the early nineteenth century. This in turn was close to collapse and was rebuilt during the current works programme. The retaining wall to the Lower Monks' Garden is almost fully original at its west end, but the eastern section had collapsed and it was necessary to reconstruct it during the current works programme to preserve the site.

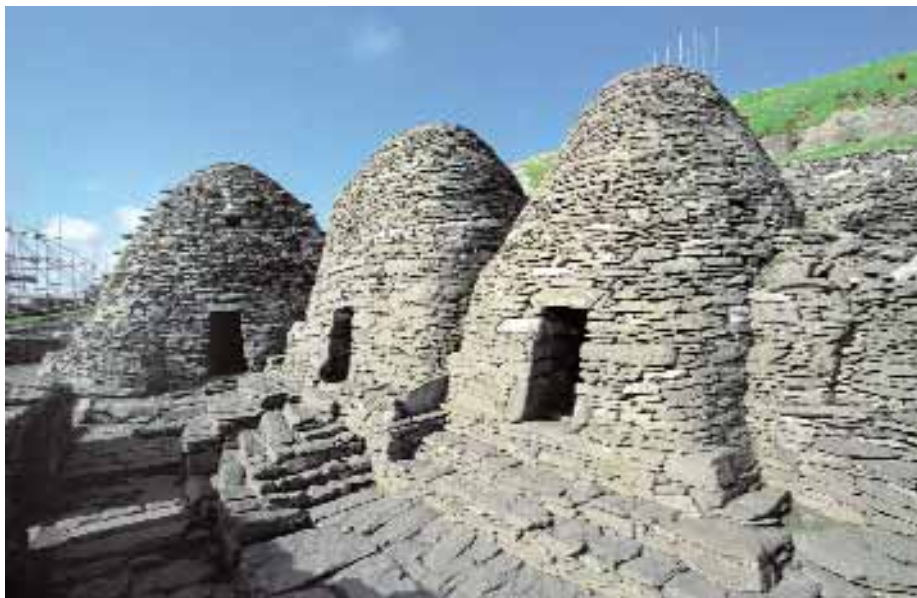
This cell lies to the east of Cell B and is very similar to it. It is probably the last to have been constructed. It is also built of large stones, but is not quite as refined. It is almost square on plan, measuring 2.75m x 2.6m. The corners are squared and lead to a rectangular capstone. There are no cupboards or special features. It retains most of its original paving and there is a drain running down the centre of the cell, under the pavement.

*Pl. 30 - View of Cells A, B and C within the inner enclosure.*

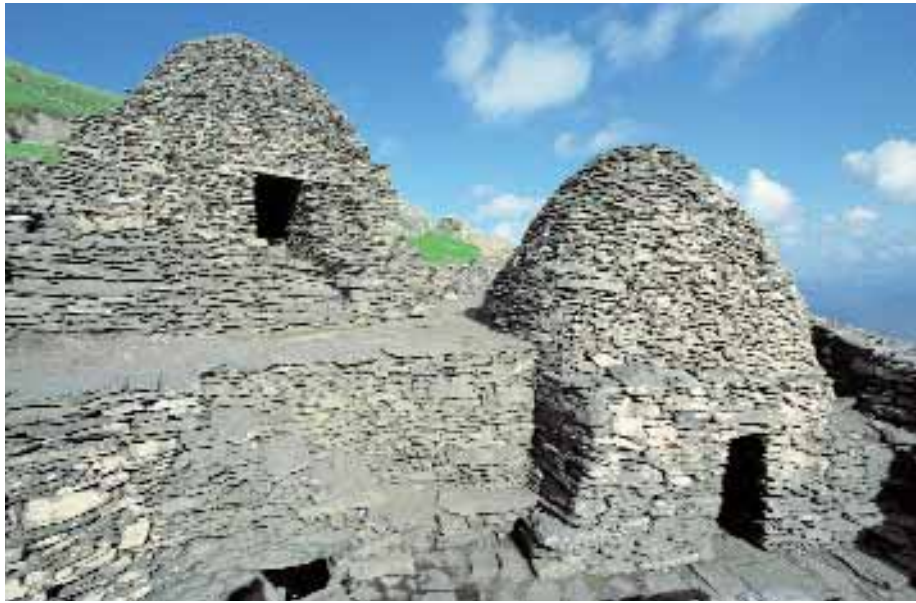
This cell lies to the north-east of Cell D and is situated at a higher level than the other cells. It is built of relatively small stones and has stepped plinths and projecting stones at upper level. It is quite spacious inside, measuring 3.65m x 3.58m, and is almost 4.0m high. Though almost square on plan, it becomes circular in shape as it reaches the roof. Most of the interior paving dates from the nineteenth century. There are some projecting stone pegs and there are holes in the walls to take two wooden beams for a loft.

*Pl. 31 - View of Cells E and F within the inner enclosure.*

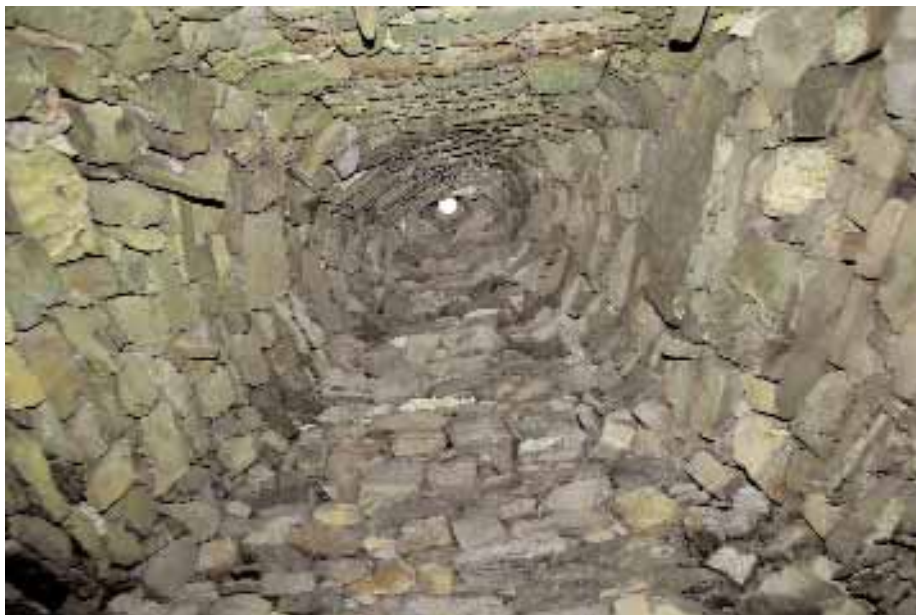
*Pl. 32 - The inner dome of Cell F, showing corbelling and projecting stone pegs.*

This cell lies to the south-east of Cell E and is built of moderately sized stones. The cell is 2.98m x 2.75m, with the corners defined up to about 60cm above the lintel, after which it becomes circular. There is a stone with a circular opening that completes the dome; it is unclear if this is an original feature. There are three cupboards in the walls and projecting stone pegs. The floor is irregularly paved and includes some upright slabs that define a raised section on three sides, where the monks would have slept.

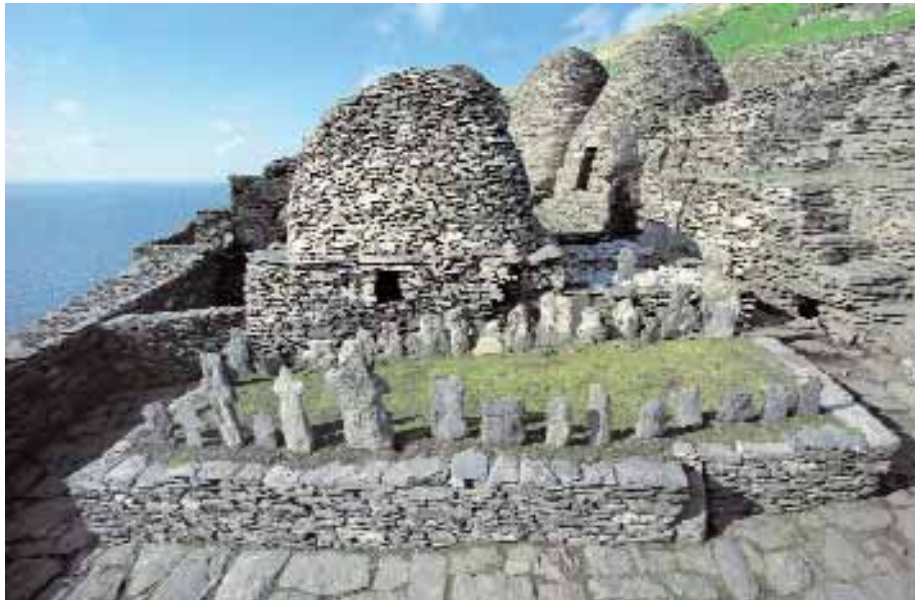
This is located to the east of the Large Oratory. It is defined by large, long orthostats along its base, against which a row of crosses and cross-slabs are placed vertically on the west side. The graveyard was bigger originally, but the east side fell away when part of the east retaining wall collapsed.

*Pl. 34 - The Monks' Graveyard within the inner enclosure.*

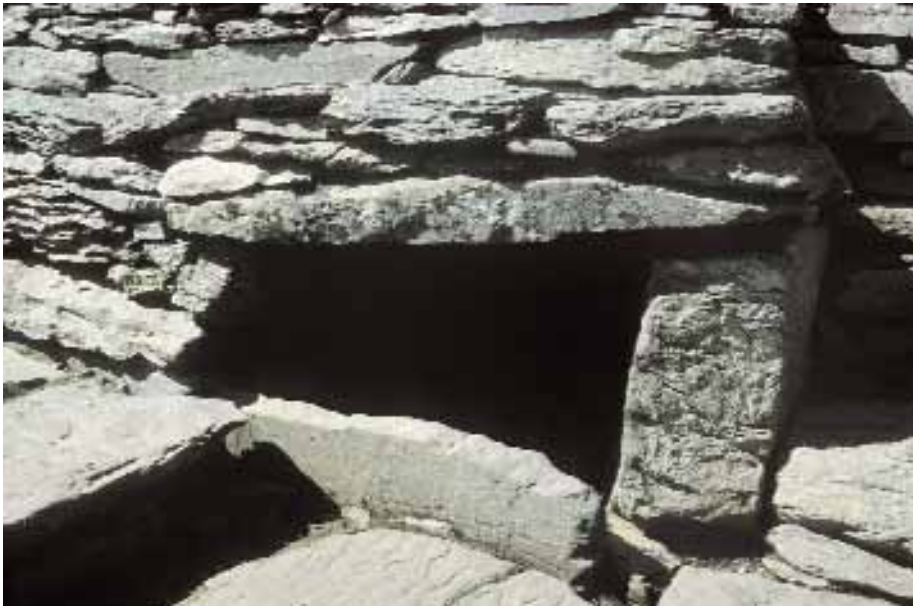
There are two cisterns located within the inner monastic enclosure. They are constructed on the exposed sloping bedrock and the sides are made up of orthostats and drystone walling. Together these cisterns can hold about 450 litres of water. There is an additional cistern to the west of Cell A, which was identified incorrectly as a souterrain prior to its excavation. There is an additional cistern outside the Monastery, below the Lower Monks' Garden, by the East Steps. This is probably associated with the Guesthouse.

*Pl. 35 - A water cistern located just below Cell B in the inner enclosure.*

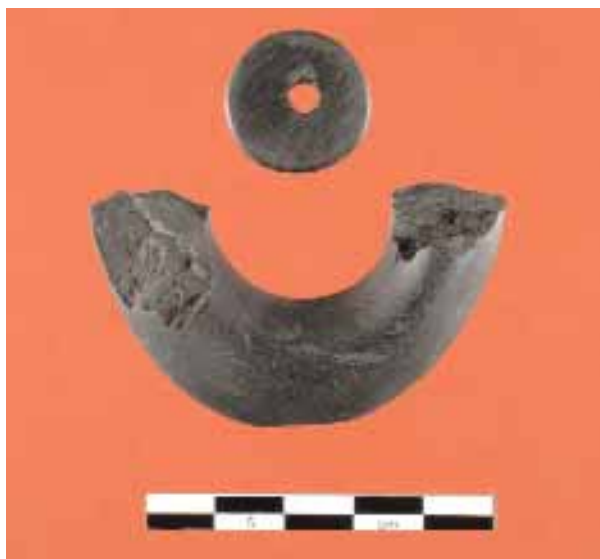
*Pl. 36 - Lignite perforated disc and fragment of ring/amulet, which were both found in the Large Oratory.*

The few finds that may be attributed to the early medieval period include part of a lignite ring/amulet and a perforated lignite disc, both of which were found in the Large Oratory. A small iron knife with wooden handle was also recovered from the Large Oratory and a hone stone was found in the lower levels of deposits on the ledge below the Small Oratory. Part of a decorated bone comb plate, with iron rivets, was found on the surface of the interior of St Michael's Church and dates to the ninth/tenth century. A bronze ring-pin (AD 1000–1075) was found in the retaining wall to the left of the eastern entrance, while a spatulate-headed stick pin (AD 1150–1250) was found in the rubble of a collapsed wall in the upper level of the Lower Monks' Garden. A small number of medieval pottery sherds, including Saintonge and Bristol wares, a bone pin, a bone gaming piece, a hone stone, some copper wire, lead and slag, were also recovered from the Lower Monks' Garden.

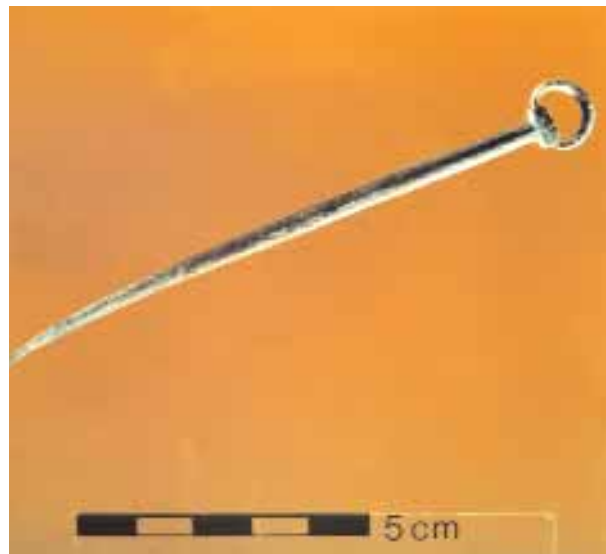
*Pl. 37 - Bronze ring-pin (eleventh century) found within the drystone wall at the earlier entrance in the Upper Retaining Wall.*

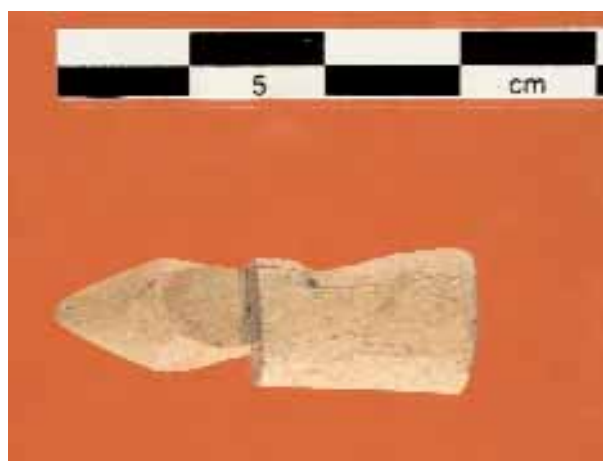
*Pl. 38 - Carved bone object (possible gaming piece) found in Lower Monks' Garden.*

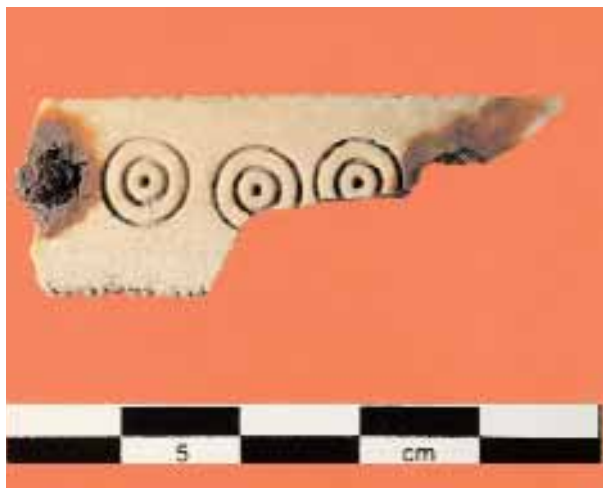
*Pl. 40 - Decorated bone comb plate (ninth/tenth century) found on the surface within St Michael's Church.*

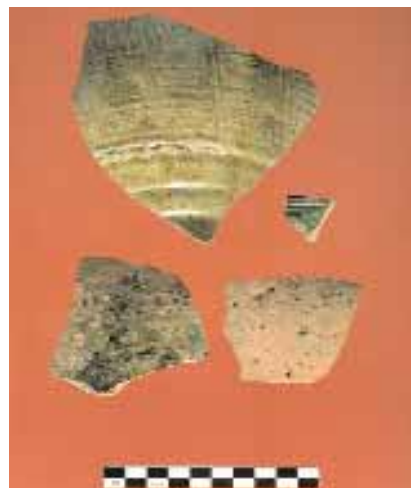
*Pl. 41 - Sherds of medieval pottery from the Lower Monks' Garden.*

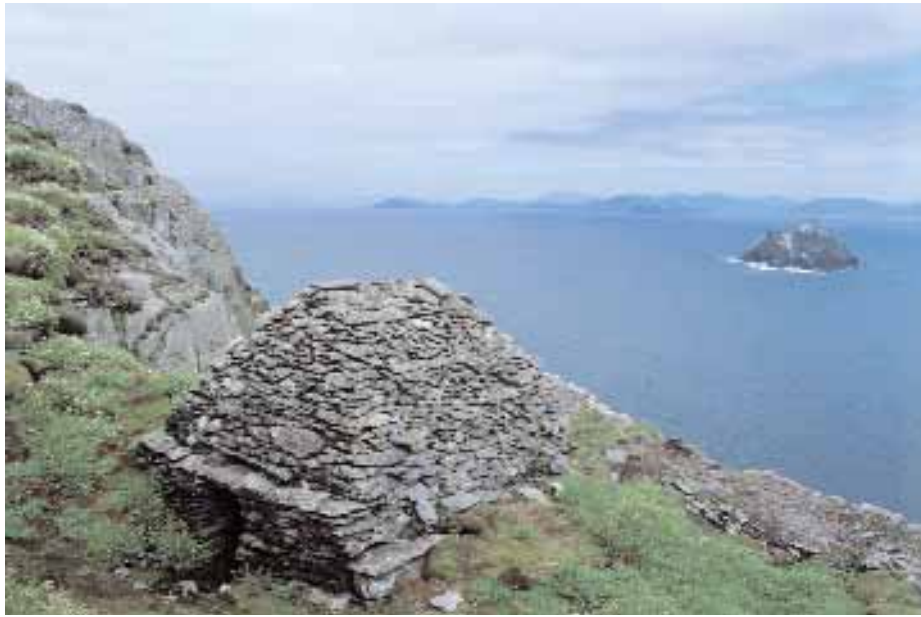
*Pl. 42 - Small Oratory prior to excavation and conservation works.*

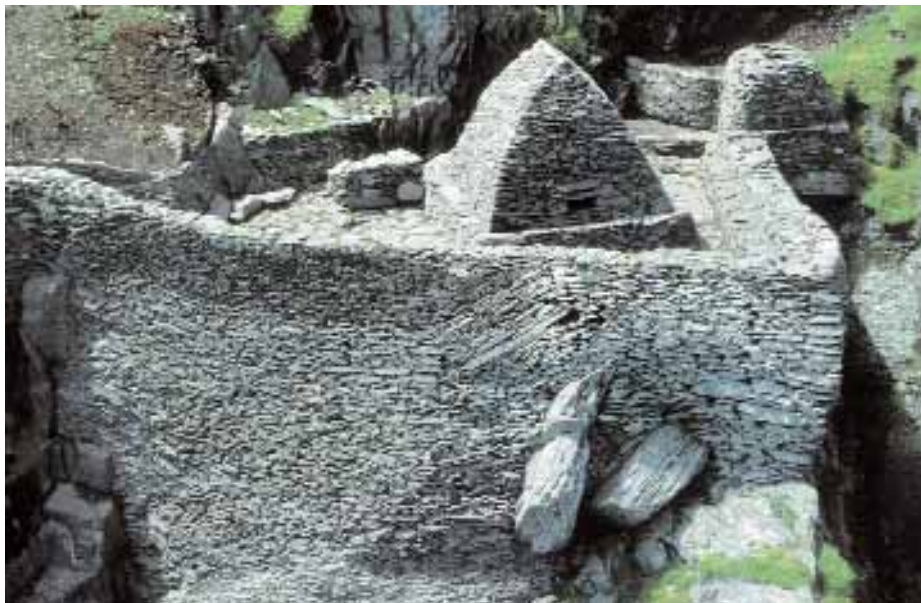
*Pl. 43 - Aerial view of the Small Oratory Terrace post excavation, consolidation and conservation works.*

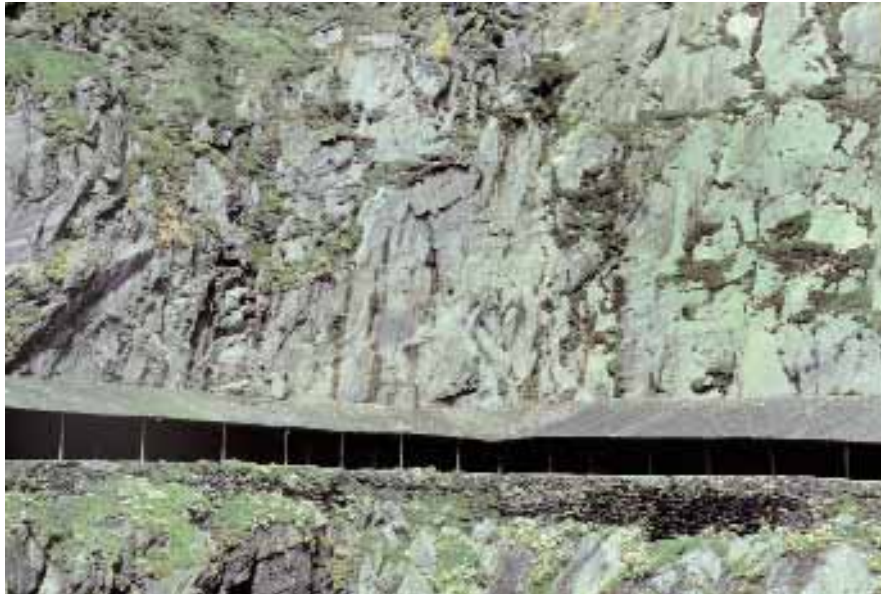
*Pl. 44 - The protective canopy at Cross Cove.*
